# Post Test Evaluation of HSCT Nozzle Acoustic Liner Subcomponents Subjected to a Hot Acoustic Durability Test

*Michael J. Verrilli and Kuan Lee*  
*Glenn Research Center, Cleveland, Ohio*

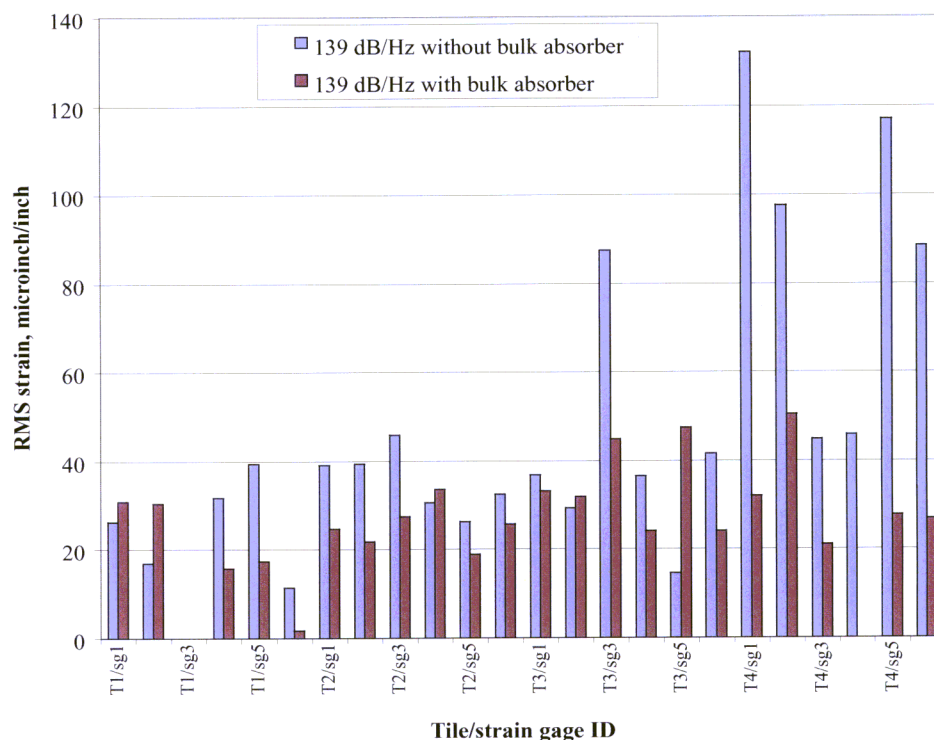
RMS strain gage data for each tile is shown in Figure 14 for the 136 dB/Hz exposure and in Figure 15 for the 139 dB/Hz exposure. Two data points are shown for each strain gage, one for strains measured in the CMC tiles without the bulk absorbers and the other for strains measured with the bulk absorbers installed. The presence of the acoustic absorbers did reduce the strain measured during the acoustic exposure in the CMC tiles relative to the exposure without the absorbers. Sine sweeps conducted both before and after the 136 and 139 dB/Hz exposures did not produce significant RMS strains (i.e. 30 microstrain and below) nor a shift in the frequency corresponding to the peak strain response, implying that no detectable tile damage occurred.

The RMS strain gage data in Figures 14 and 15 can be compared to the measured mechanical properties of SiC/SiNC. The SiC/SiNC composite's tensile proportional limit at room temperature is 8 ksi, as determined through acoustic emission measurements taken during a uniaxial tensile test (reference 13). The modulus is 14 MSI and the strain at the proportional limit is 2400 microstrain. The maximum RMS strains for each tile are shown in Figure 16. The peak RMS strains measured during the acoustic fatigue loading are considerably less than the composite's proportional strain. For CMC's exposed to non-oxidizing conditions, fatigue loading below the proportional limit typically yields runnout lives and no composite damage develops (reference 14), consistent with the conclusion above that the 139 dB/Hz exposure did not damage the tile.

Figure 14 – RMS strains on the CMC acoustic tiles measured during exposure to 136 dB/Hz acoustic load at ambient temperature. The first two characters of the data point labels for the x-axis denote the tile number, and the rest of the characters denote the strain gage number.

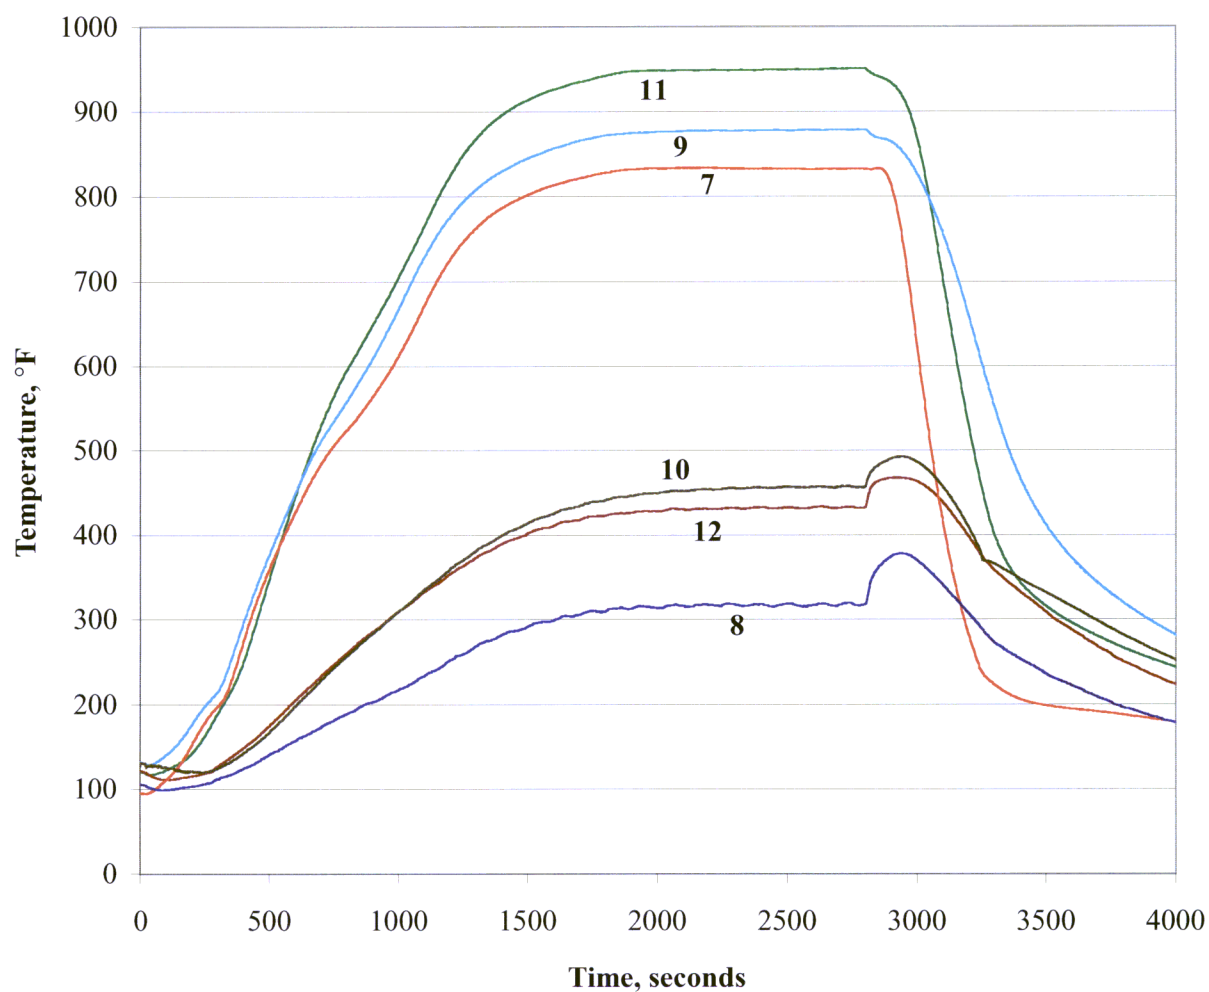
Figure 19 shows the temperatures measured on the hot and the cold sides of the TPS panels during the first cycle. For clarity, the data shown is for one of the two TPS panels. Note that the temperatures on the cold side of the TPS increase at the end of the cycle, when the heating system is turned off and the acoustic loading was stopped. One possible explanation for this temperature increase may be due to the fact that the airflow through the system was much lower when the noise modulators were turned off. The reduction of the cooling air and subsequent cooling of the specimen holder through conduction to the TPS may have contributed to this rise in TPS temperature.

Figure 19 – Temperature versus time for the TPS under CMC tiles DC 109B and DC 105 (3 & 4). Data is for cycle 1. The curve labels are the thermocouple identification numbers shown in Figure 13.

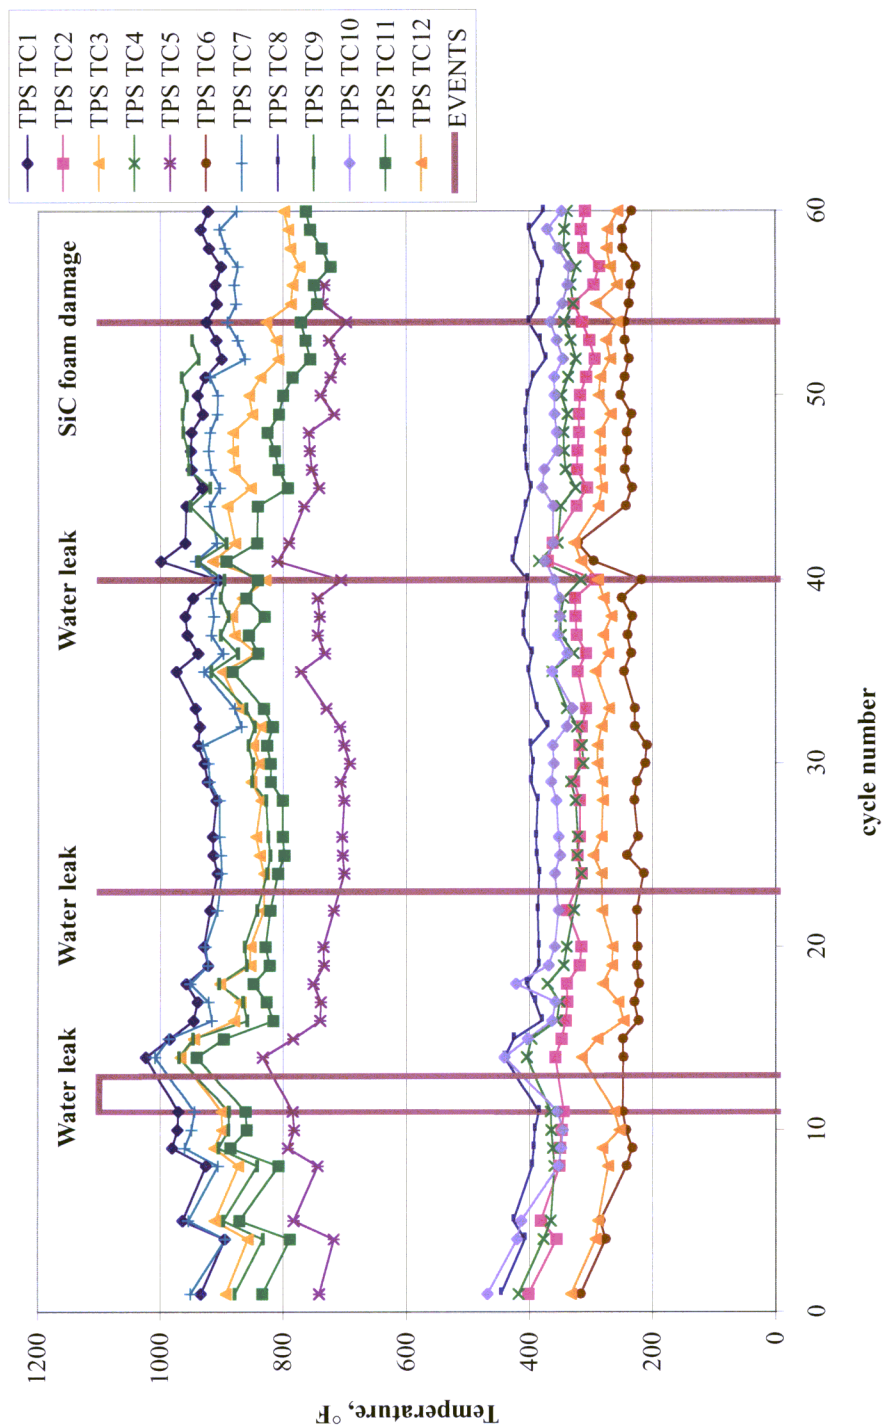
Figure 20 shows the maximum TPS temperatures for all twelve thermocouples from the beginning of the durability test through the last cycle (60). Also shown in the plot is an indication of cycles where unusual test events occurred, such as system water leaks and the observation of significant damage to the SiC foam acoustic absorber. No indication of a cycle by cycle increase or decrease of the temperatures was measured. However, increases of the peak temperatures occurred after the TPS was exposed to water during system cooling leaks during cycles 12 and 40. Also, note that the temperatures measured at the TPS joint (thermocouples 3,4, 9, and 10) are within the range of the temperatures measured away from the joints. This suggests that the insulative capability of the joint was similar to the baseline TPS for the test conditions used here.

Figure 20 – Maximum and minimum temperatures for each thermocouple on the TPS as a function of cycle number.

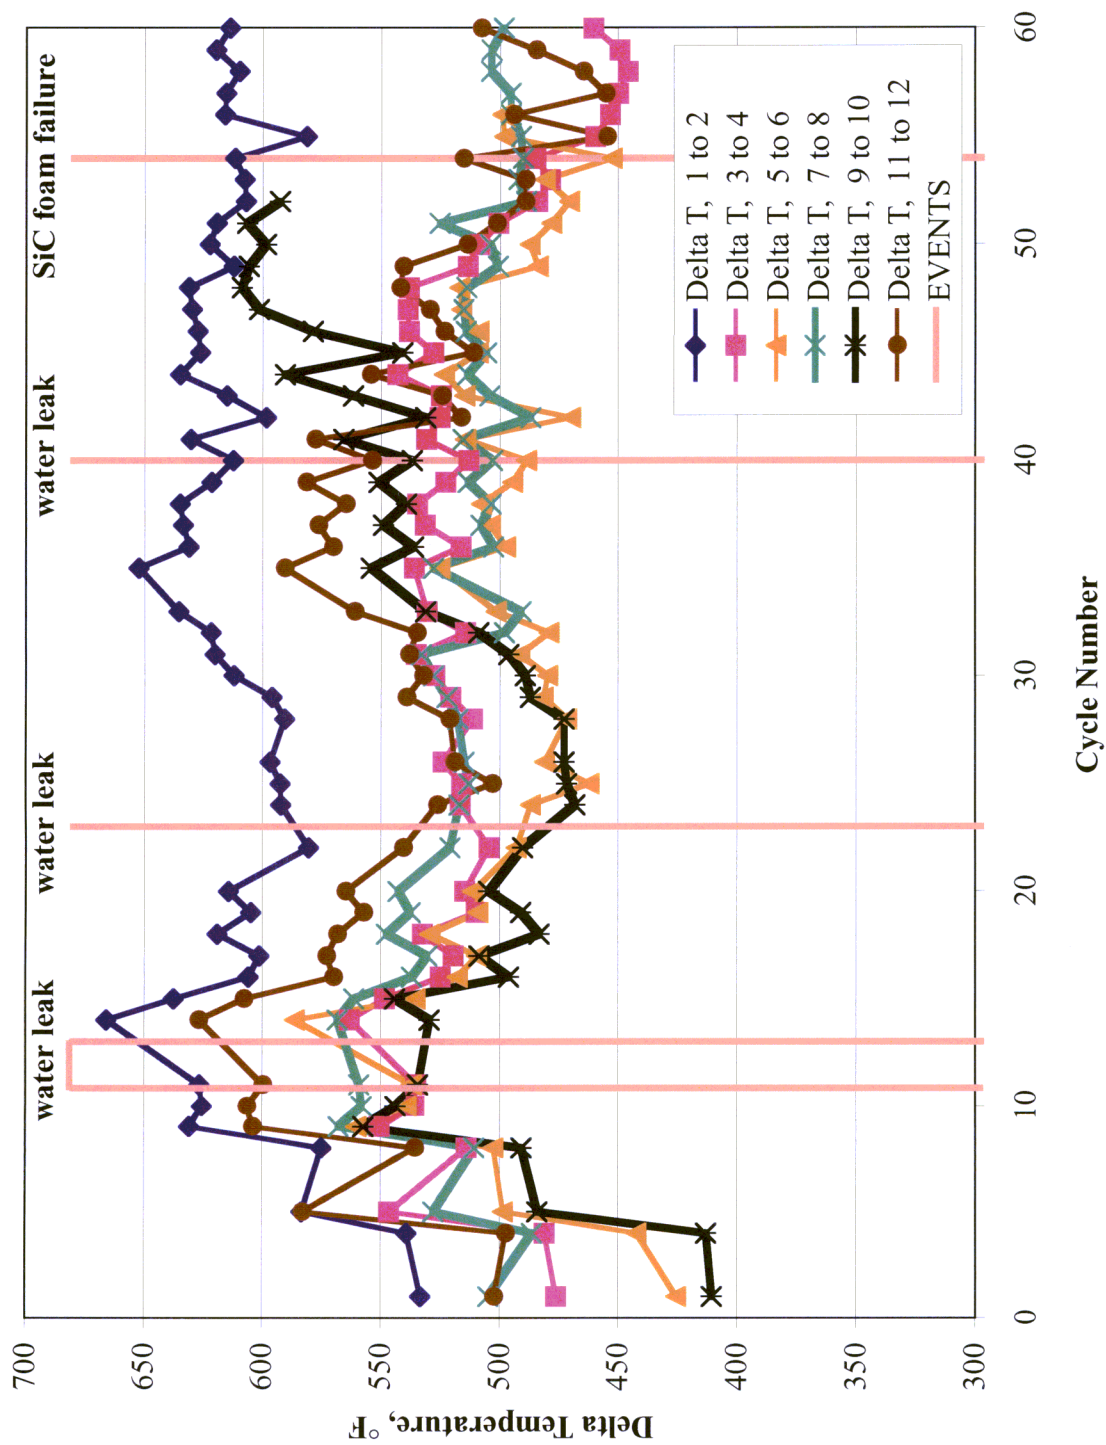
The through-thickness temperature differential ( $\Delta T$ ) for the TPS as a function of cycle number is shown in Figure 21. An indication of cycles when an usual event occurred is shown as well. In general, the  $\Delta T$  was cyclic during the test. It increased during the first 12 cycles, decreased during the next 20 cycles, increased again until cycle 36, and then generally decreased until the end of the test. The cooling system water leaks that occurred during cycles 10 through 12 and cycle 23 may have contributed to the cyclic changes in the  $\Delta T$ .

Figure 21 – Maximum through-thickness delta T for the TPS as a function of cycle number.
